Re: 63rd Street Restoration and Planting Plan | Vancouver, WA

Ecological Land Services, Inc. (ELS) has prepared this restoration and planting plan on behalf of Legacy 6 Construction (Mark Wubben), addressing inadvertent impacts to a wetland and its buffer in response to stop work order *No.S18-000006* for Clark County Parcel No. 105190000, at 8122 NE 63rd Street, in Vancouver, Washington.

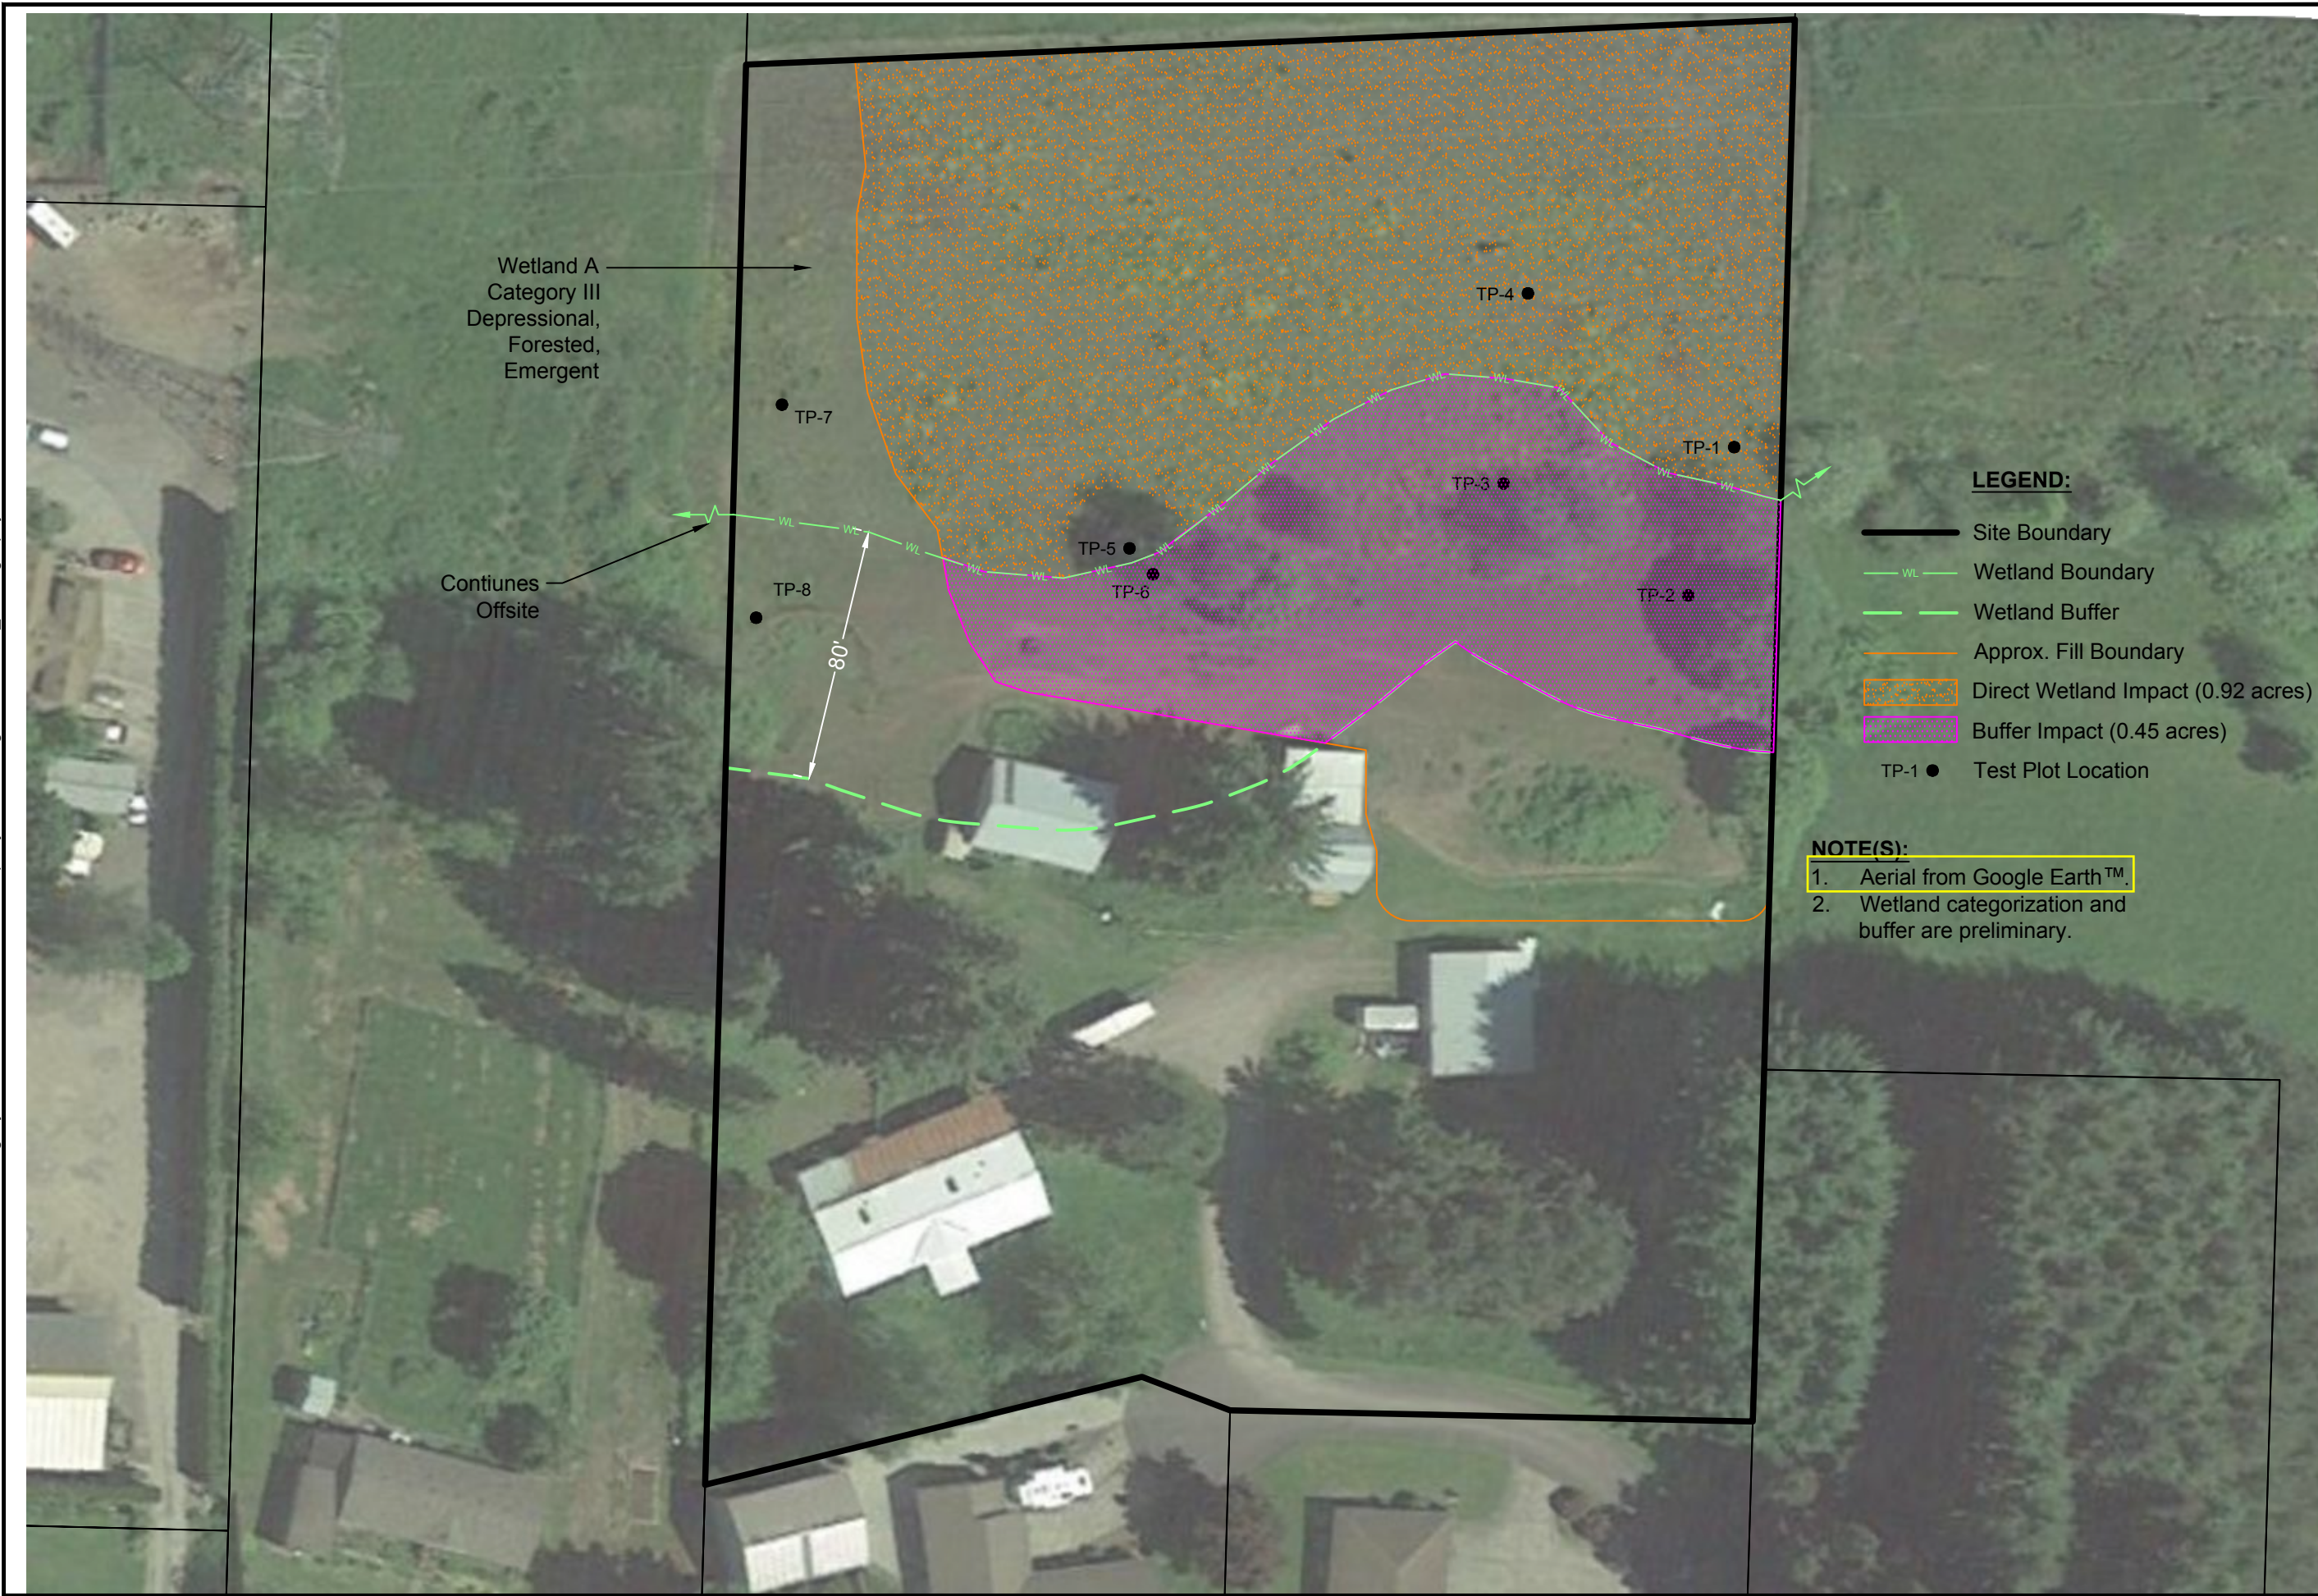
Figure 2
SITE MAP
63rd Street Property
Legacy 6, Inc.
City of Vancouver, Clark County, Washington
Section 8, Township 2N, Range 2E, W.M.

The study area consists of a single family residence with several outbuildings in the southern portion of the parcel, and a grazed horse pasture in the northern portion, where the majority of the fill material was placed. The onsite wetland is located within the northern portion of the parcel and was categorized through a preliminary rating using Washington State Department of Ecology's *Wetland Rating System for Western Washington: 2014 Update* as a Category III, depressional, emergent, forested wetland. The VMC *Section 20.740.140: Wetlands* defines buffers for Category III wetlands with a low habitat score adjacent to high intensity land use as 80 feet (Figure 2). During the site visit, ELS biologists noted that fill had been placed in the onsite wetland and buffer, save a small linear strip along the western property boundary, causing approximately 0.92 acres of direct wetland impacts, and 0.45 acres of buffer impacts. The impact varies from a fill depth of just one or two inches, up to 1.5 feet in a small area. The average depth of fill over the entire area is about 0.5 feet.

Restoration will be implemented to restore the impacted portion of the onsite wetland to its pre-existing topography, hydrology, and vegetation where grading and fill placement occurred. Proposed restoration will occur through excavation of approximately 250 cubic yards of fill material within the wetland, down to the original soil surface, and removing the material to the uplands, with care taken to create a grade of no greater than 4:1 where it will be deposited. The uplands prior to the fill placement consisted of pasture grasses. The post-placement spoils within the uplands will be seeded to grass and will continue to be used for horse pasture. No net change to the wetland buffer is anticipated as a result of this soil placement, provided the area is seeded and no final grades exceed a 4:1 slope.
