Existing Conditions Report

The McGillivray Boulevard Safety & Mobility Project will develop recommendations to improve safety and comfort for everyone who travels on McGillivray Boulevard.

The Safety & Mobility Project is evaluating McGillivray Boulevard from I-205/Chkalov Drive to SE 164th Avenue and portions of Chkalov Drive and Village Loop Drive. Major intersections on McGillivray Boulevard, SE Chkalov Drive, and Village Loop Drive are also being evaluated as part of this project.

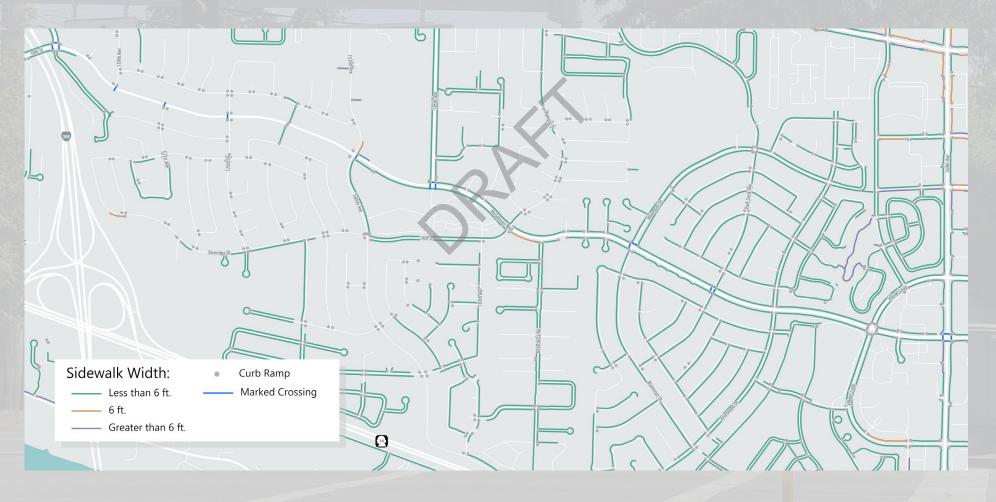
Today, the portion of McGillivray Boulevard west of SE 136th Avenue is challenging for people walking on the corridor, as sidewalks are **no sidewalks** except for a small segment on the south side of the corridor between SE 132nd Avenue and SE 136th Avenue. In this area, people must walk in the street, sharing space with parked cars, people riding bicycles and other small mobility devices.

East of SE 136th Avenue, sidewalks are provided on both sides of McGillivray Boulevard, though sidewalks are less than six feet wide and in poor condition.

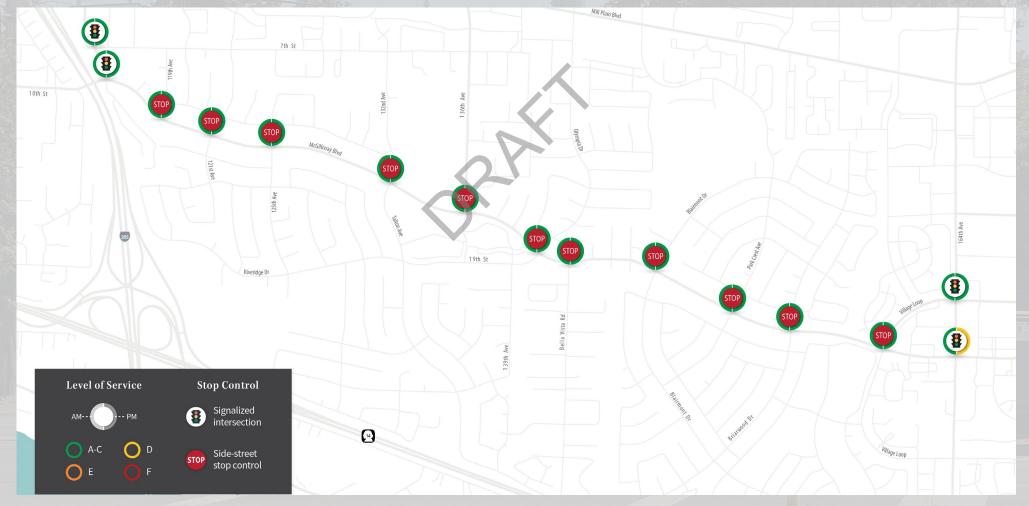
Intersection LOS was evaluated during the morning and evening peak hours at the study intersections. The analysis indicates that all intersections operate at LOS C or better, except for the SE 164th Avenue intersection with McGillivray Boulevard, which operates at LOS D during the evening peak hour. This is primarily due to delay experienced by northbound and eastbound drivers making left-turns.

Travel time between SE 164th Avenue and SE Chkalov Drive was also evaluated. Travel time was found to between approximately eight minutes in each direction during both peak hours. The consistent travel time, along with intersection LOS results, indicates that **congestion is minimal on the corridor**, even during peak hours.

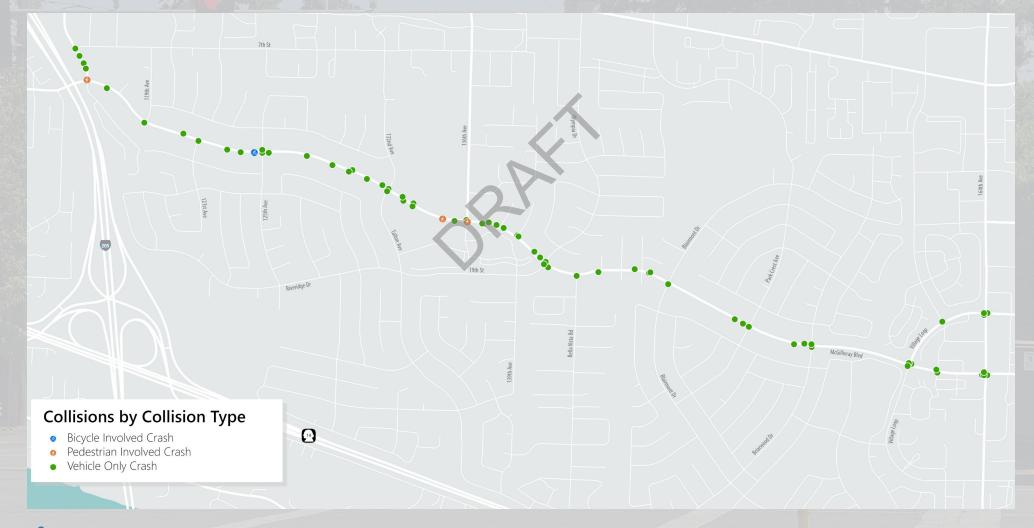
As shown in the image below, there were **three collisions involving pedestrians** that occurred of the time period analyzed and **one collision involving a person riding a bicycle**. All other collisions only involved vehicles. There was one fatality, the pedestrian involved in the collision at SE Chkalov Drive, which occurred during inclement weather (ice and snow).

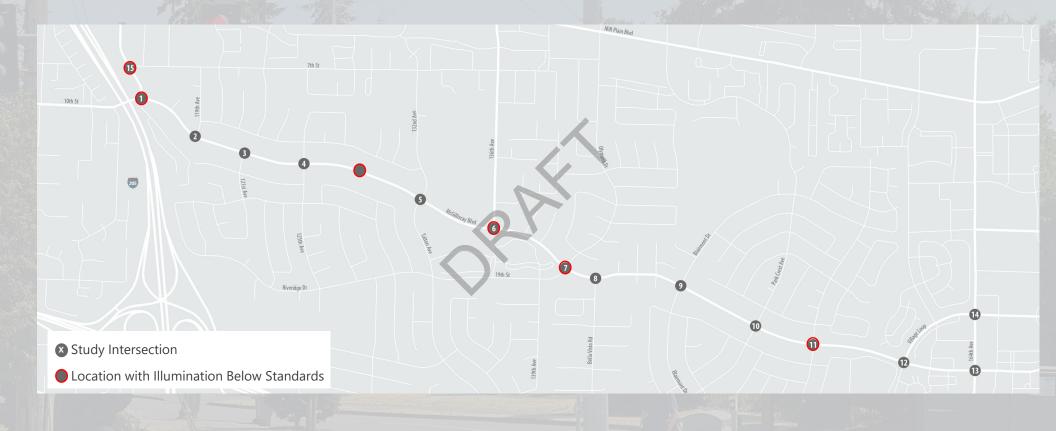
The project team took photometric readings at major crossings and intersections to determine where the existing illumination does not meet illumination standards. Study intersections and crossings where illumination was identified as not meeting the City's standards are circle in red on the image below. As shown, illumination improvements are also needed at the existing mid-block crossing. While this project will not specifically address illumination, this is identified as a **long-term need for the corridor**.
