RE: **McGillivray Boulevard Safety and Mobility Project – Existing Conditions**

McGillivray Boulevard Safety and Mobility Project – Existing Conditions

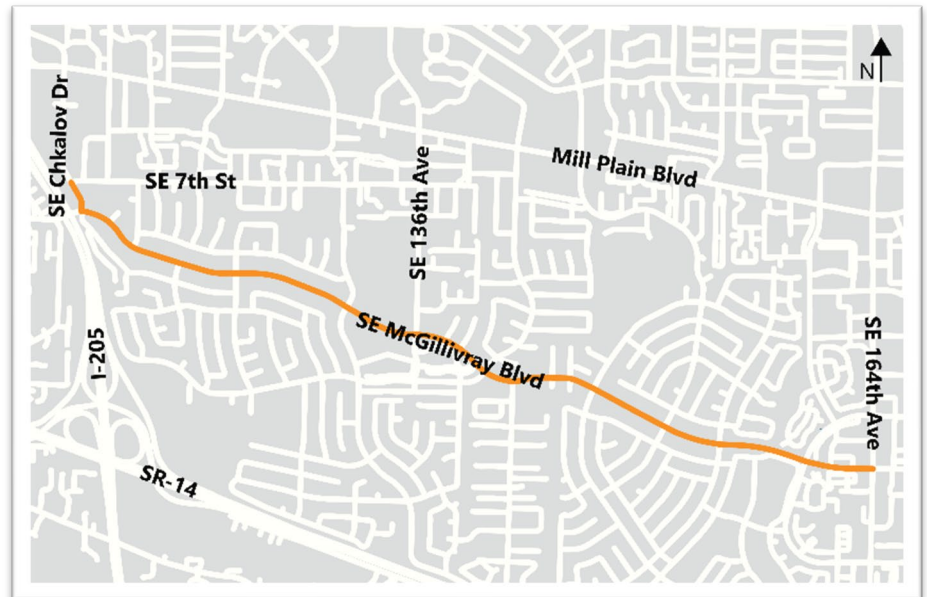
Figure 1: McGillivray Boulevard Project Corridor Boundary

The McGillivray Boulevard Safety and Mobility Project (Project) is evaluating potential changes to improve safety and mobility for all who travel on SE McGillivray Boulevard between SE Chkalov Drive and SE 164th Avenue, and SE Chkalov Drive between SE 7th Street and SE McGillivray Boulevard, as shown in **Figure 1**. The Project is evaluating how McGillivray Boulevard can better meet the needs of people walking, biking, rolling, accessing transit, using a small mobility device, and driving.
